CARBONSEAL™ HTI
ENGINEERED REPAIR SYSTEMS
PROCESS PIPING

Introduction to Process Pipe Repairs

PROCESS PIPE CASE STUDIES

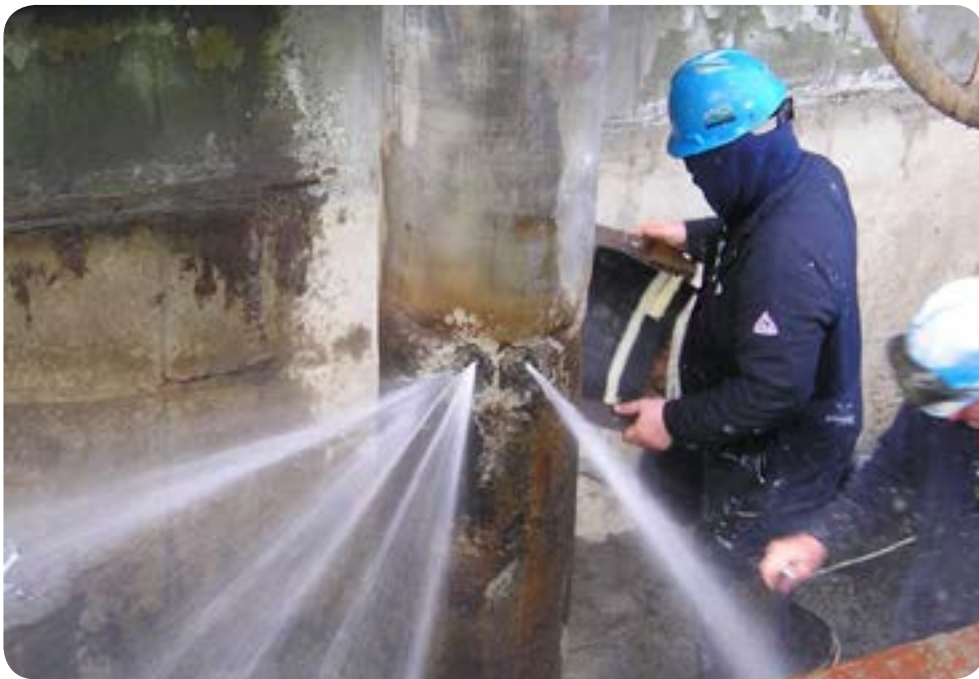
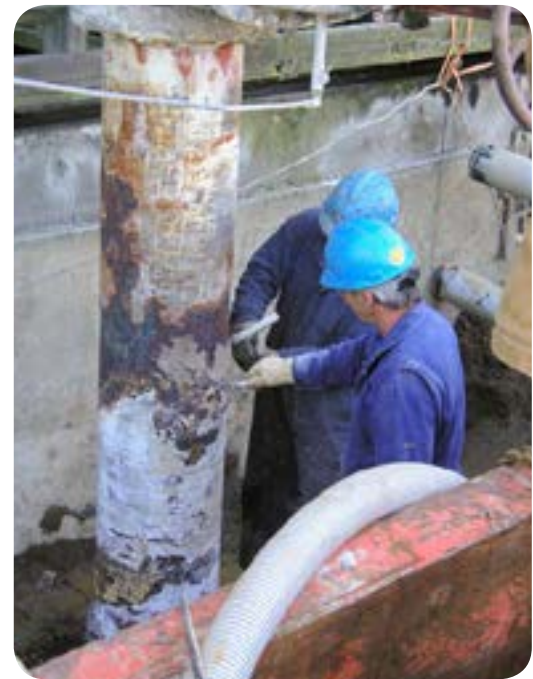
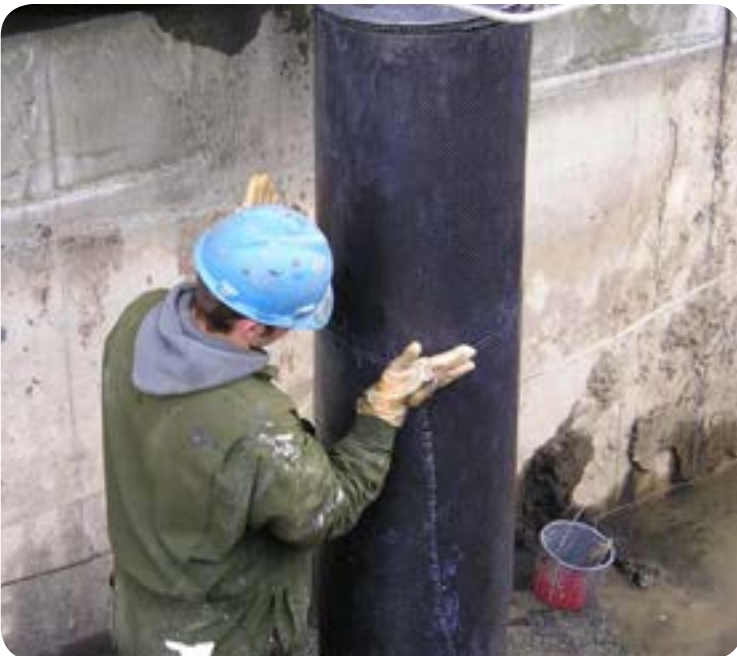
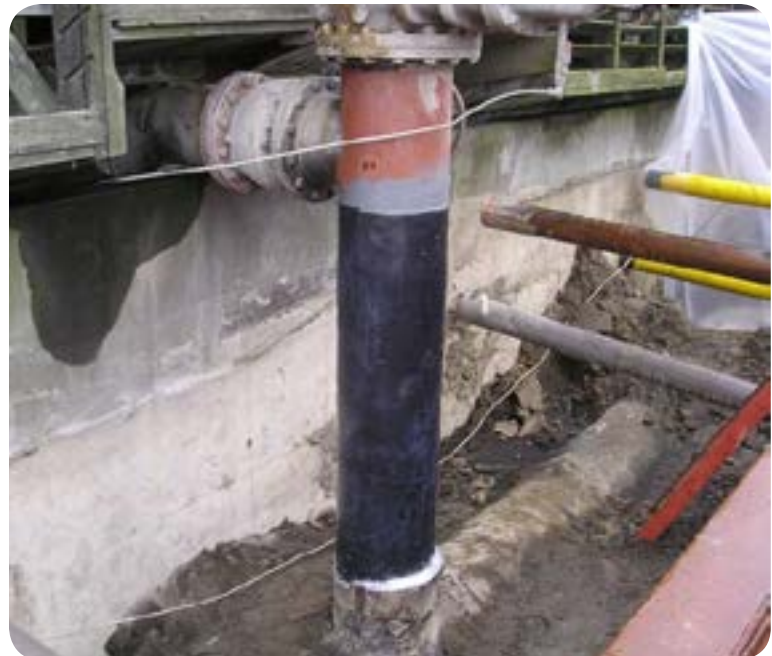
POWER PLANT FACILITY

This Washington state facility had extensively corroded steel riser pipe. The corrosion had resulted in pitted areas and water leakage below ground. The 3/4 inch thick pipe could no longer maintain a rating of 60 psi. After cleaning and repairing the steel, HJ3 installed carbon fiber wrap and UV topcoat to protect the risers providing an impermeable to pressurized water. This client saved 50% to 70% cost savings over alternative methods. The installation was completed in a few days install with no down time.

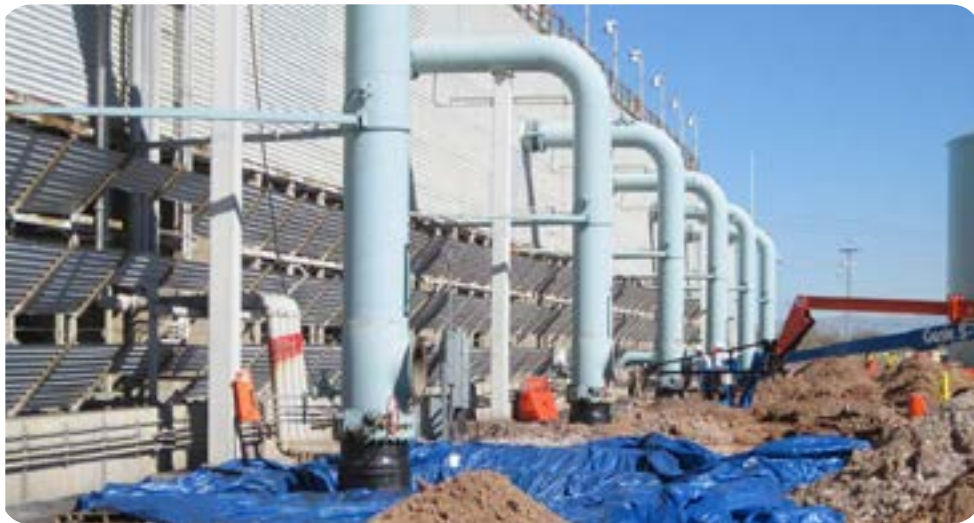
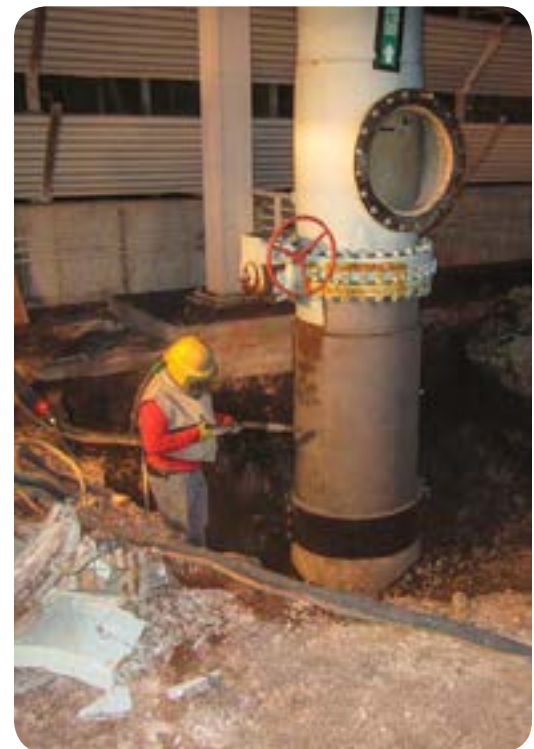
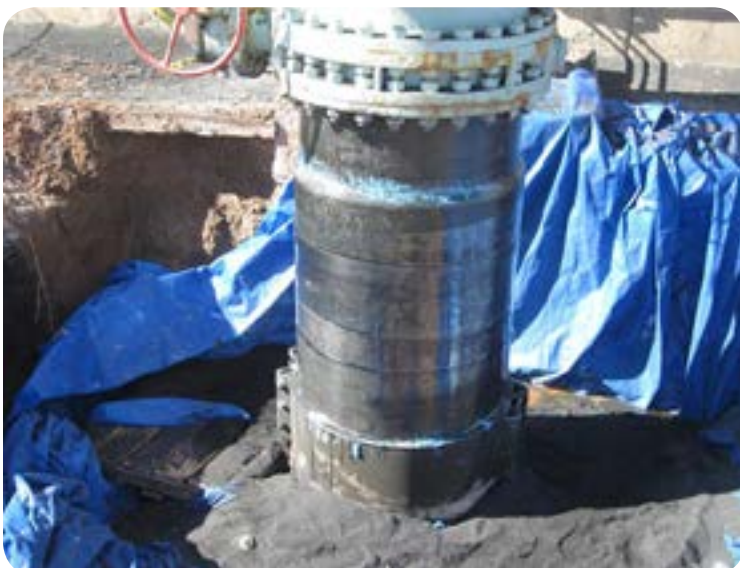
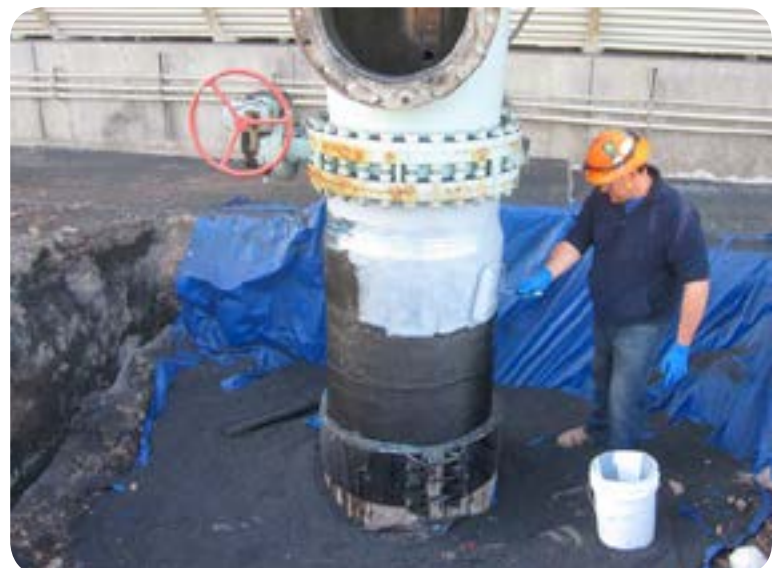
POWER PLANT FACILITY

Twenty-two riser pipes are used to carry water to cool steam that has previously passed through a turbine. Over time, the riser pipes have corroded and cracked. Two of the risers had failed completely. Before the risers could be repaired, they were excavated and the concrete diaphragms were removed. The exposed steel surface was cleaned to near white metal and primed. Saturated CarbonSeal™ fabric was applied to the clean, primed pipes. An abrasion and UV-resistant topcoat was then applied to protect the system. Finally, steel sleeves and new concrete diaphragms were installed at the base of each pipe.

Replacement of the corroded risers would have incurred significant material and downtime costs. The client saved approximately \$700,000, plus months of downtime by repairing versus replacing. Additionally several tons of CO2 were prevented from being emitted into the atmosphere from new steel and concrete manufacturing.

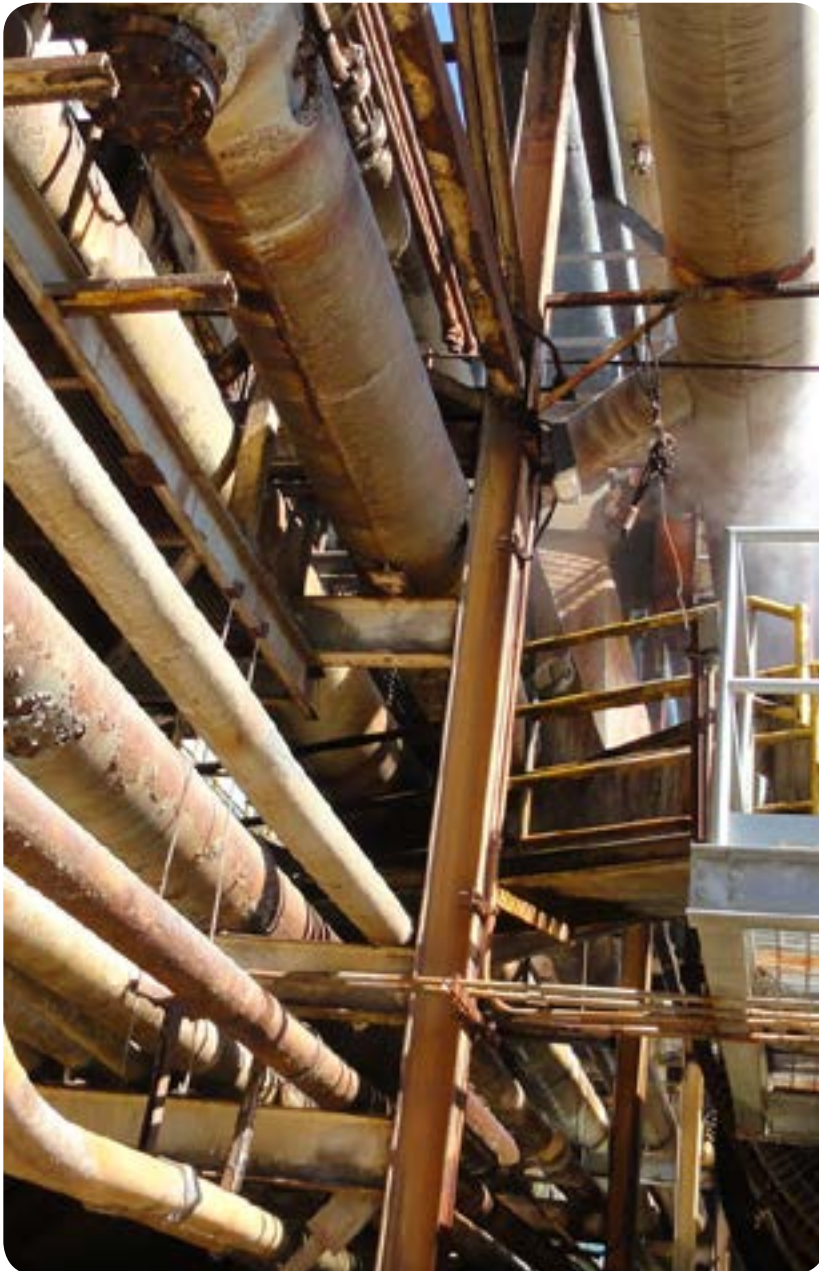
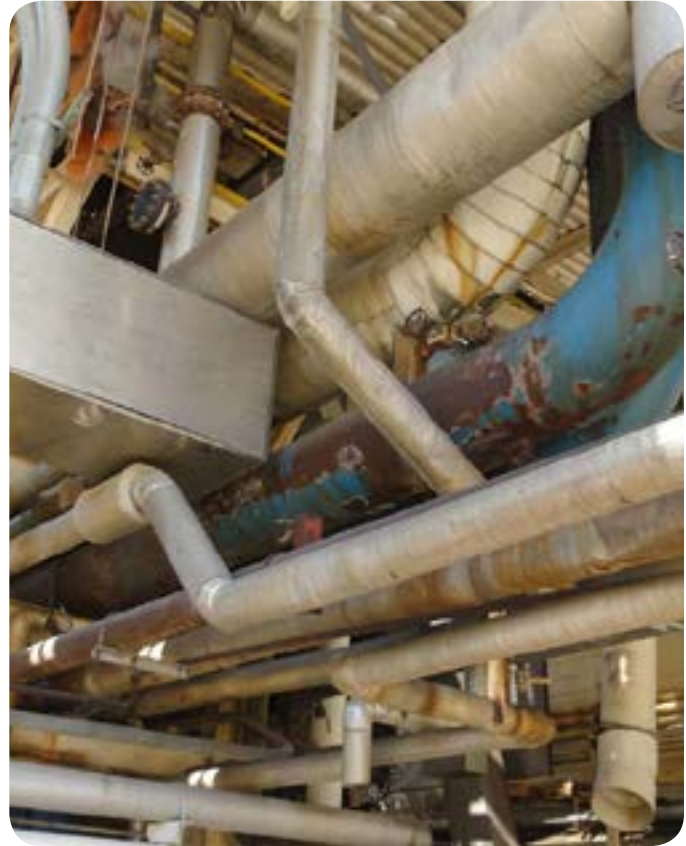
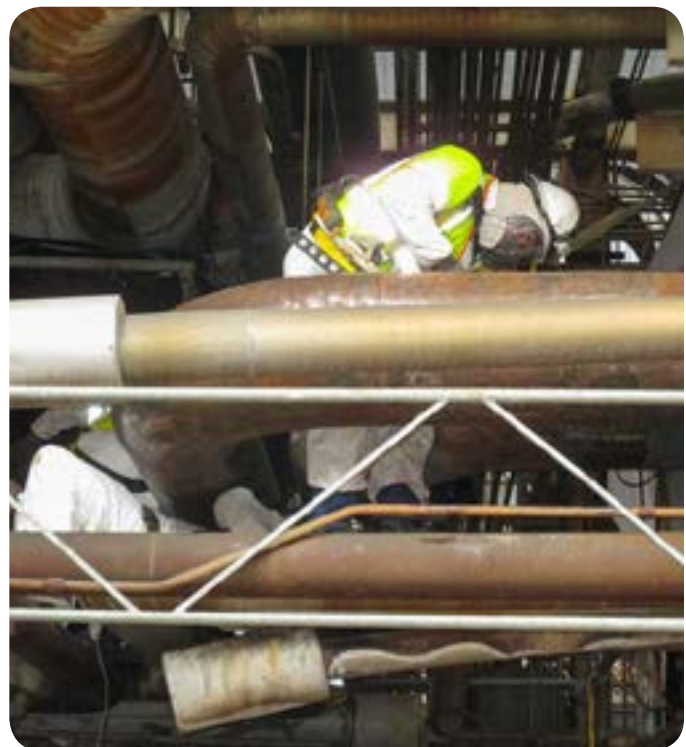
AGRICULTURAL FACILITY

This agricultural facility has network of Class 4, carbon steel pipelines, estimated 700 LF total length (supply and return) 18" diameter, that had moderate to severe internal and external corrosion. Also, there was moderate-to-severe internal cooling water corrosion and fouling which caused the majority of the leaks and damage to piping.

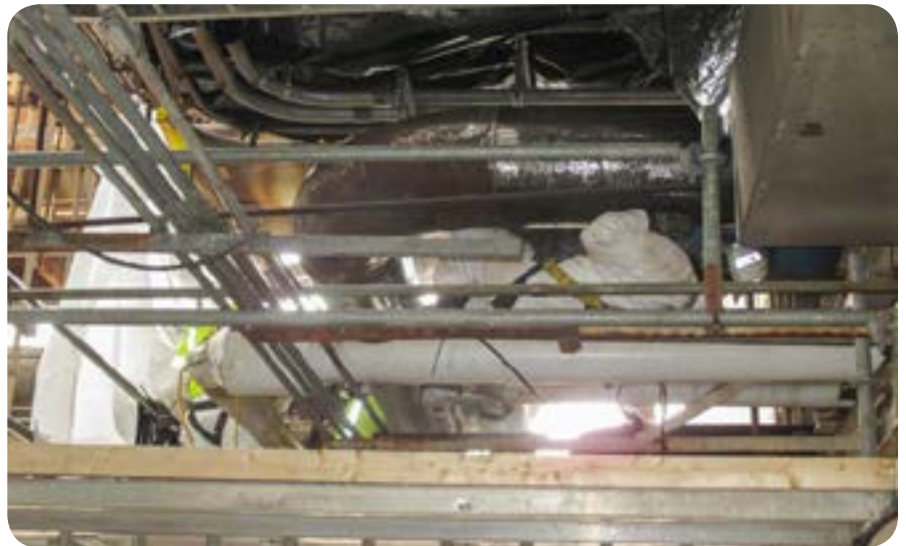
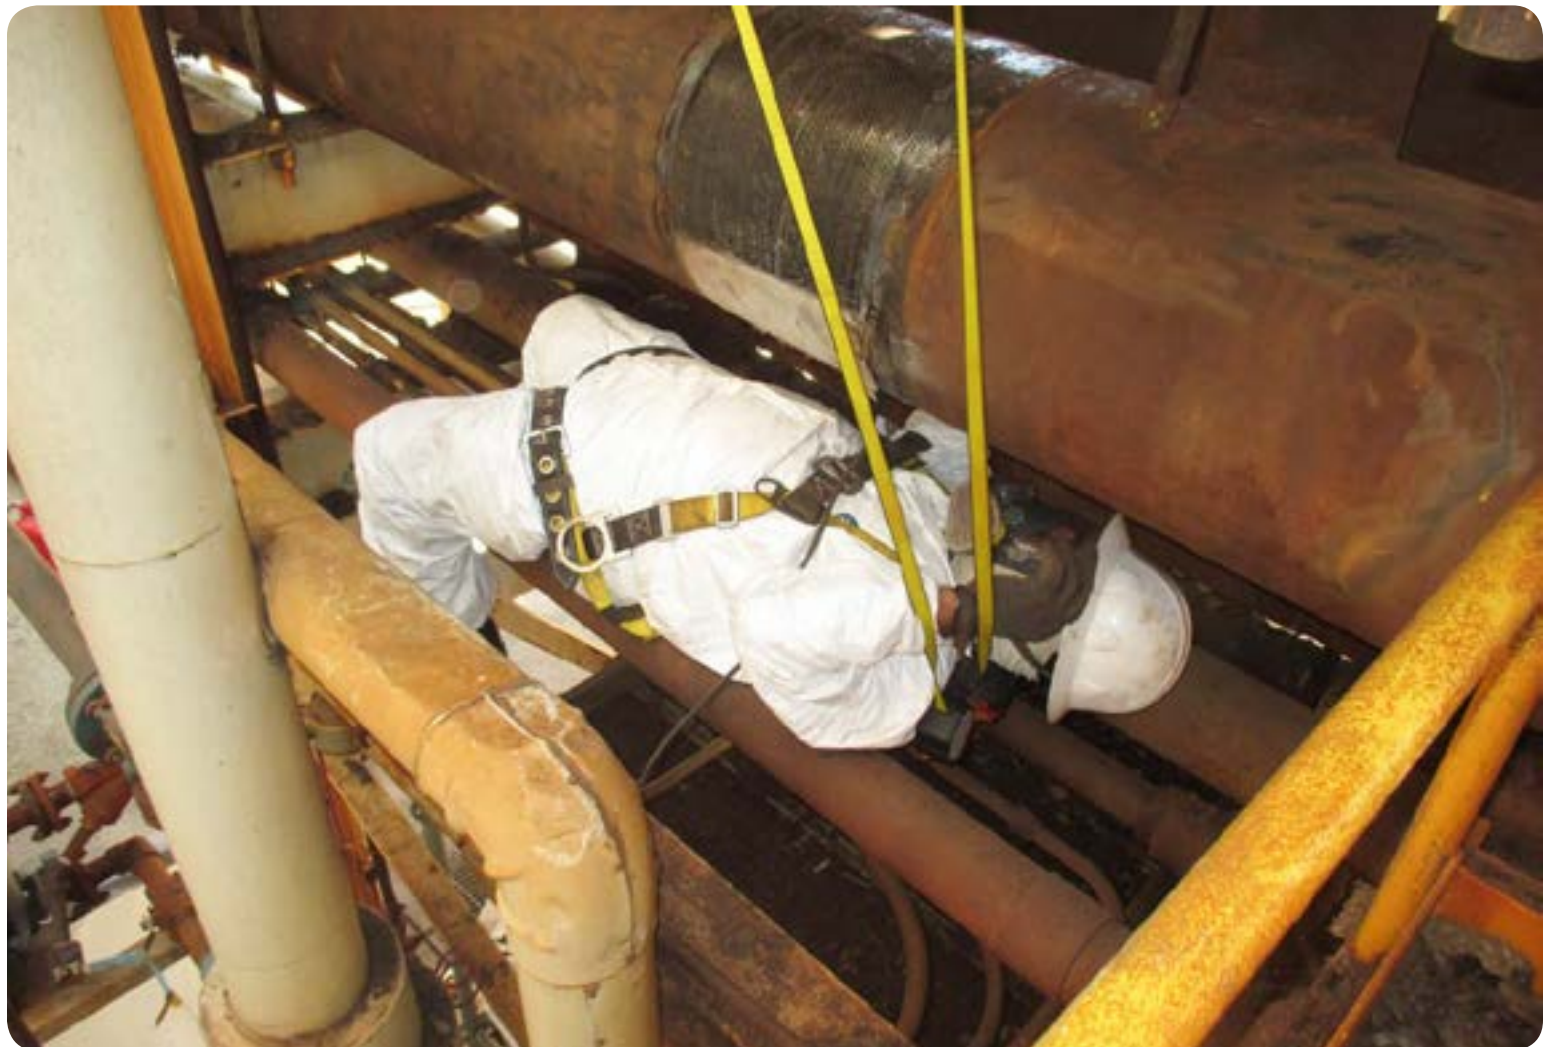
This agricultural facility has network of Class 4, carbon steel pipelines, estimated 700 LF total length (supply and return) 18" diameter, that had moderate to severe internal and external corrosion. Also, there was moderate-to-severe internal cooling water corrosion and fouling which caused the majority of the leaks and damage to piping.

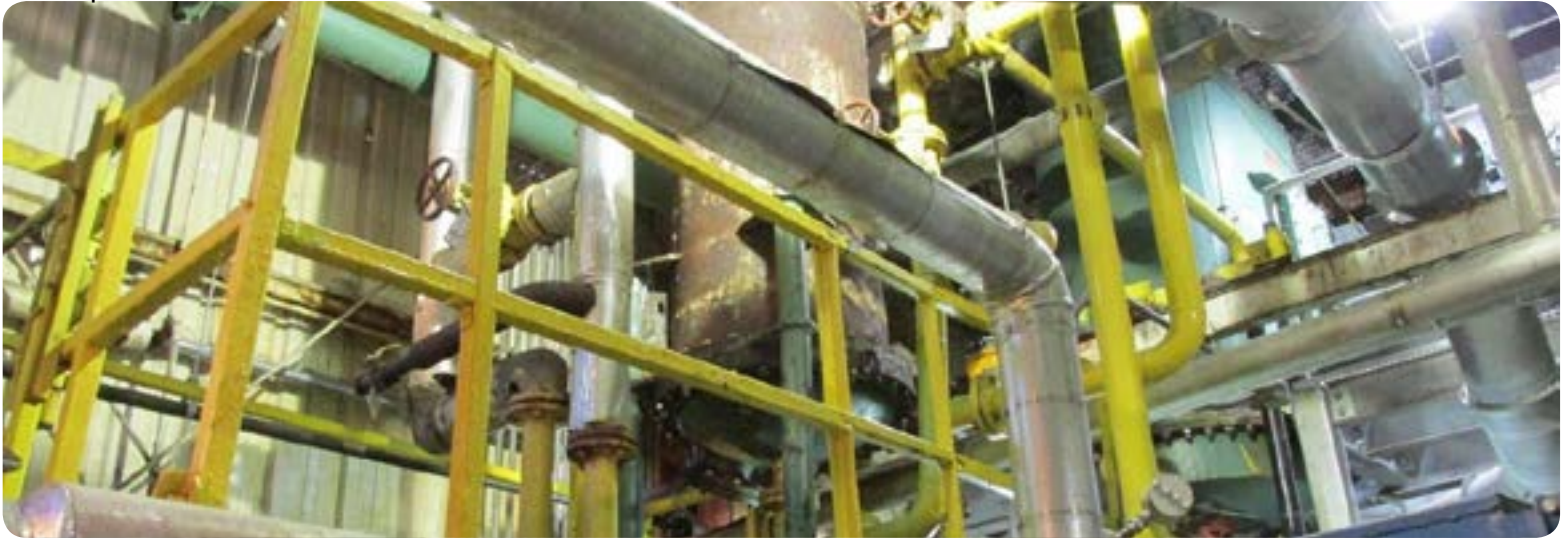
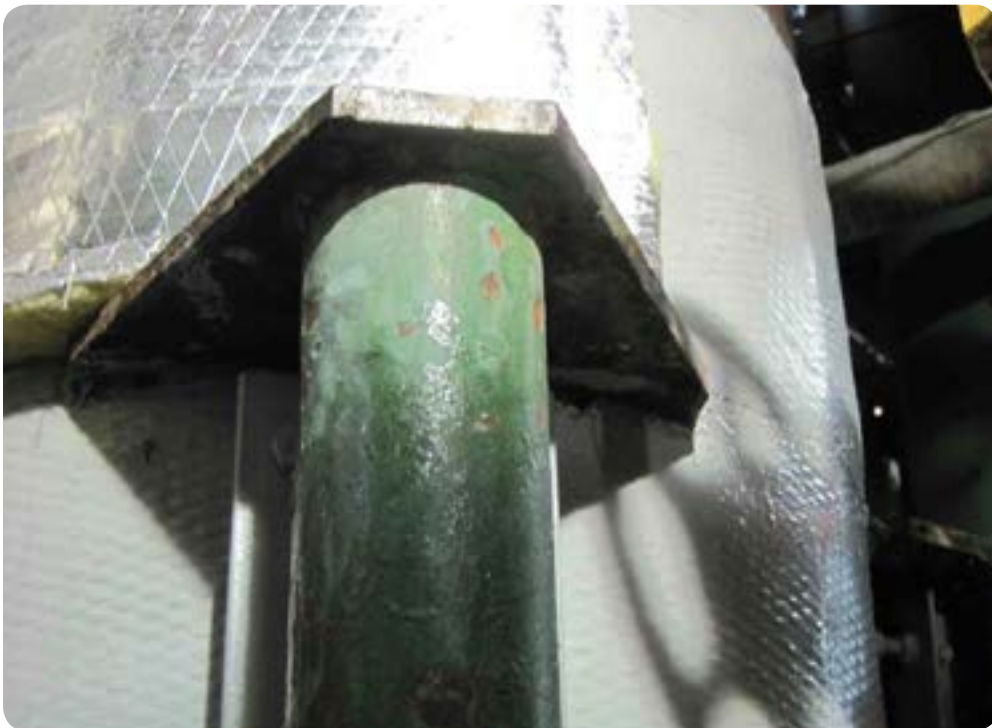
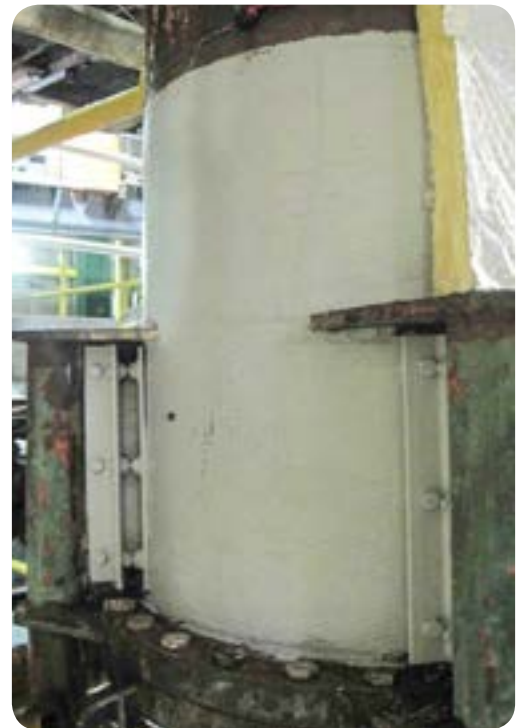
AGRICULTURAL FACILITY

This agricultural facility had a vessel heat exchanger with erosion/corrosion in its shell. The client wanted to use CFRP to help achieve the desired pressure rating for this ASME pressure vessel. The steel vessel required structural strengthening to be able to withstand original 75psi operating pressure and surface temperatures up to 365°F.

The 29"-diameter steel vessel had been previously patched two times with a "non-code repair", and needed a stronger, the code compliant repair. Steel thinning had resulted in the vessel's inability to withstand normal operating pressures. HJ3's CarbonSeal system was installed in 2 days and returned the vessel to its original strength, without requiring a shutdown.
